## COAL CAR HISTORIC RECONSTRUCTION

### Reconstruction From the Bottom Up

May 30, 2008

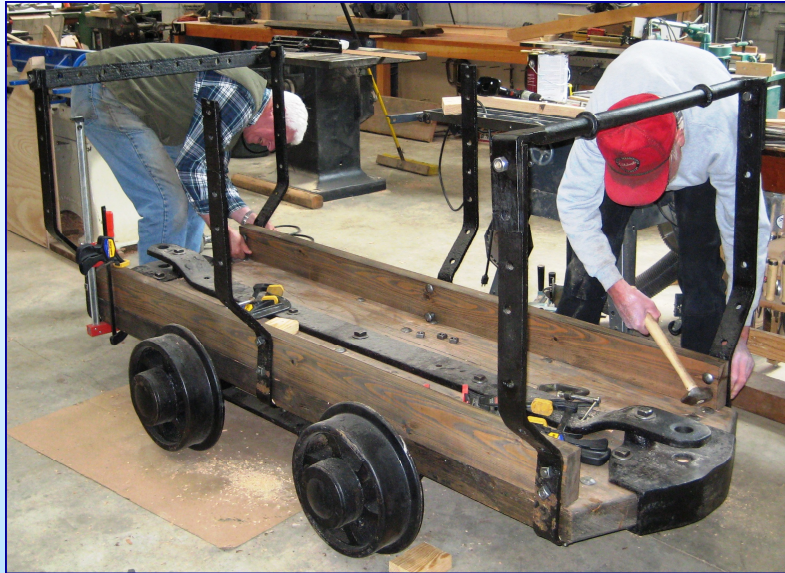
Bill Hall and Hugh Hansen reconstructing the coal car.

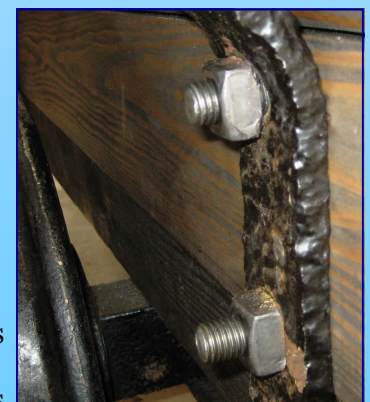
In this historic reconstruction, even something that sounds as simple as bolting on boards requires care and attention. Once the bolts are placed in their custom-drilled holes, they are pounded into the wood on the front. Next, wrenches are used to screw on the square nuts one quarter turn at a time. They are tightened as tight as they will go. Since the heads of the bolts are on the inside, this leaves a quarter inch to an inch of bolt hanging out on the outside of the car. When the car was in use, these over-hanging bolts would have been a safety hazard for the coal miners. Bill will be cutting off the excess so it is flush with the square nuts and then "peening" the ends of the bolts. Peening involves hitting the ends of the screws with a hammer so that the threads are compacted together. This makes it so that the bolts cannot unscrew, which would have been an important safety feature in the mines with the constant jostling of the cars. Bill made the decision about this extra finish work based on the likely engineering of the car, given concerns about the car's durability and the miners' safety.

Over-hanging bolt ends.
