**BRONSON WAY BRIDGE  
SEISMIC RETROFIT AND PAINTING**

FEB. 6, 2023 TRANSPORTATION COMMITTEE MEETING

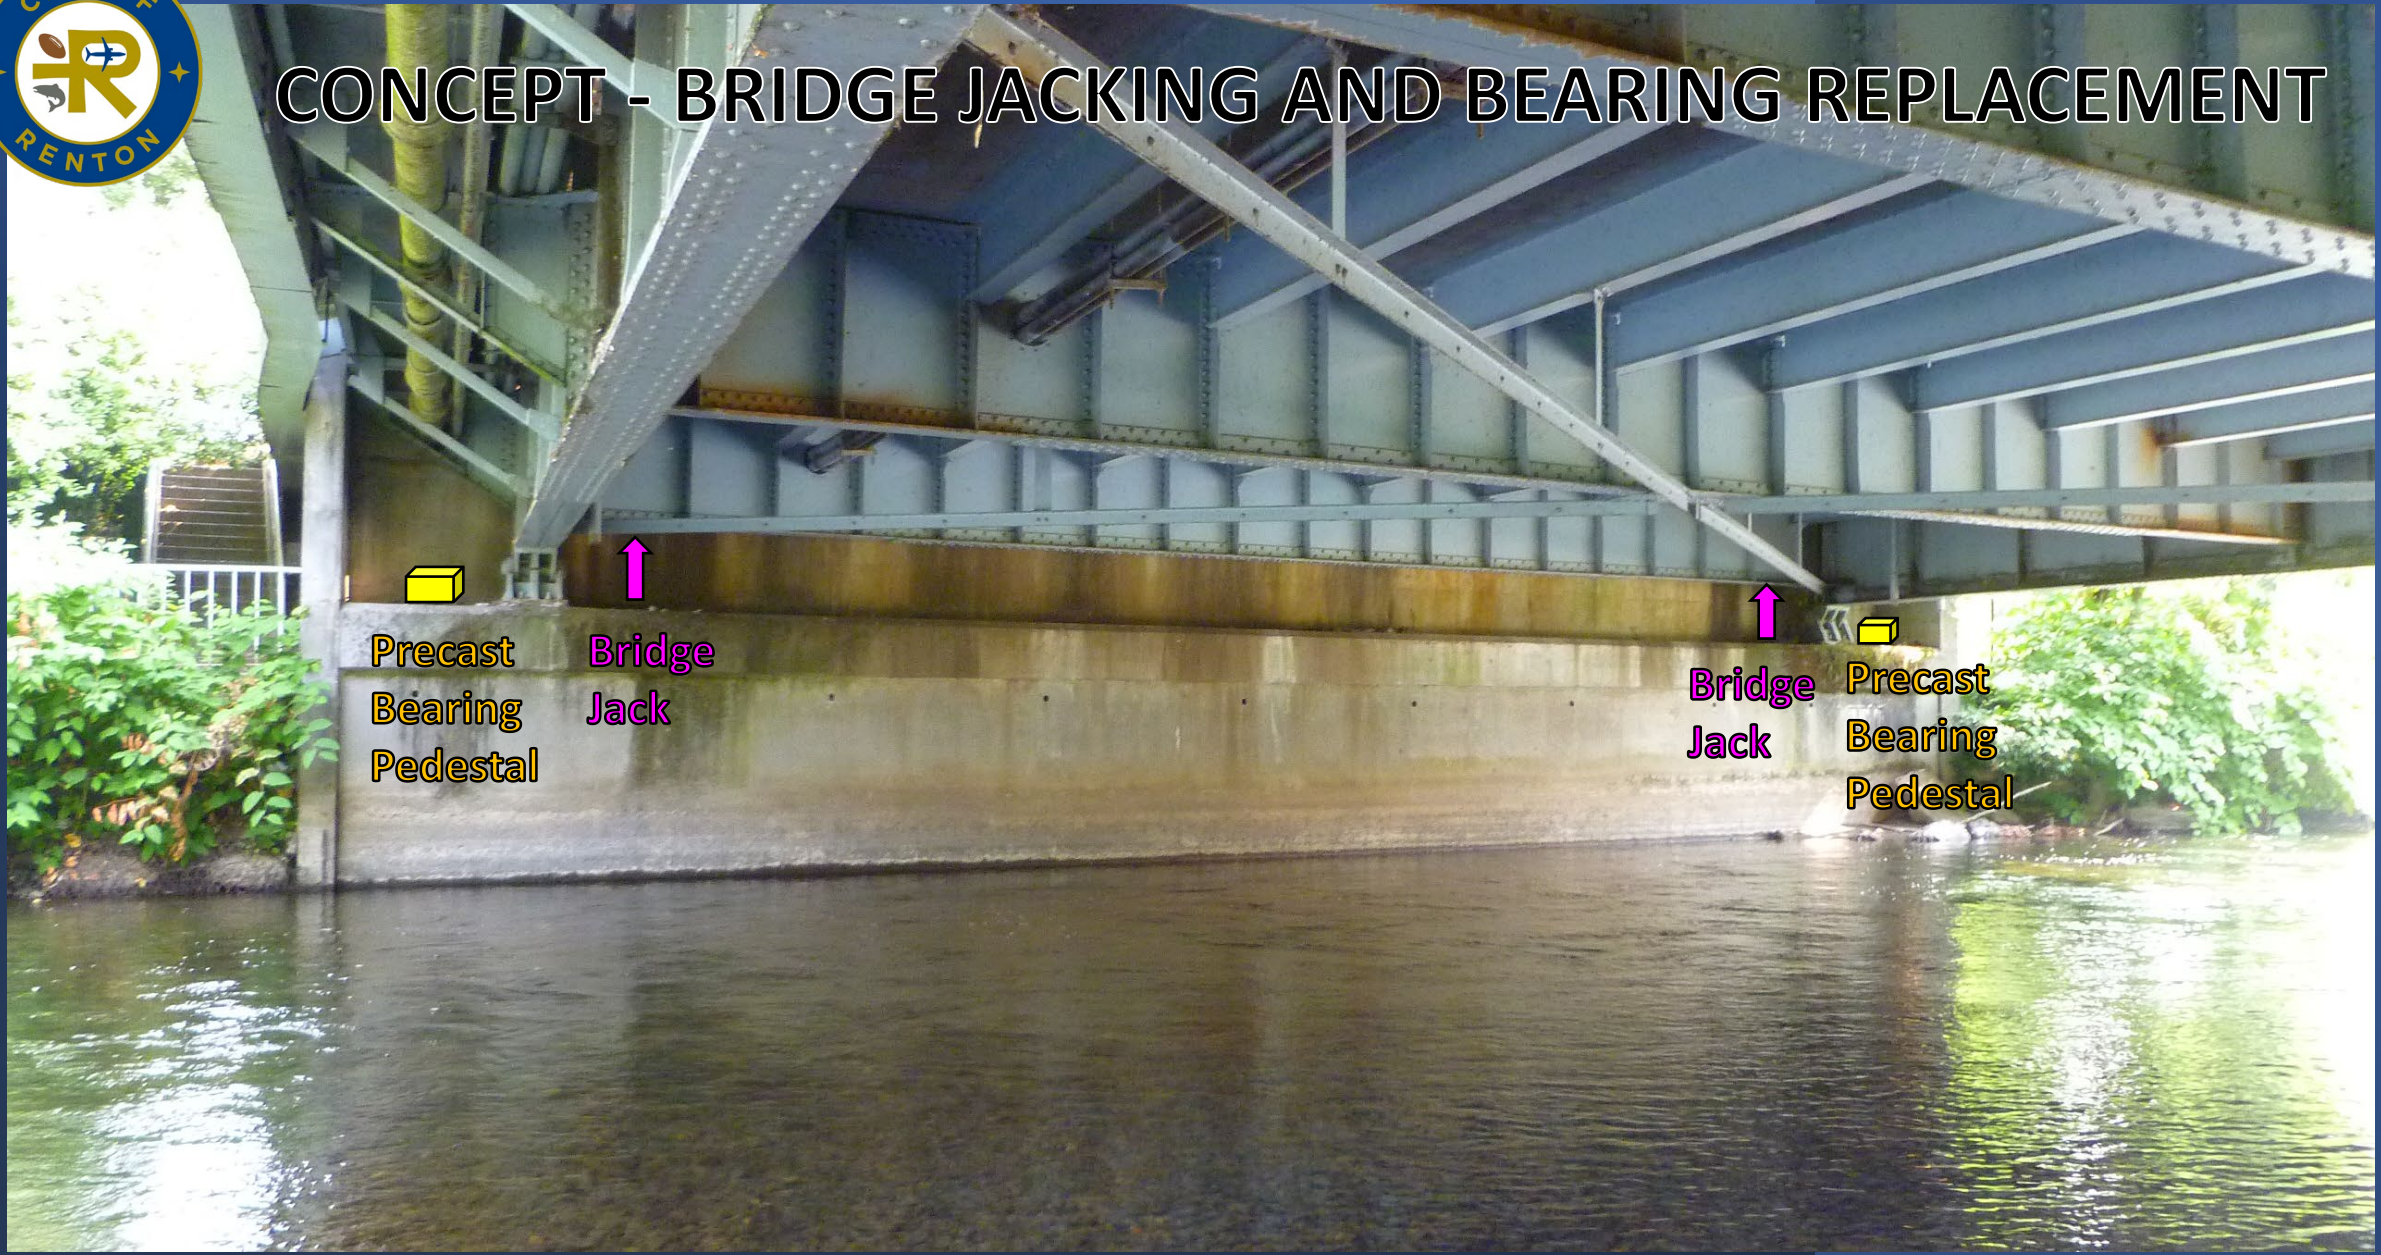
# CONCEPT - BRIDGE JACKING AND BEARING REPLACEMENT

Precast  
Bearing  
Pedestal

Bridge  
Jack

- Suspension of Work: Oct. 14, 2022 (Procure new elastomeric bearings)
- Work Element (2): Requires full bridge closure. Bridge jacks used to elevate superstructure (span 2) to replace bearings. No traffic allowed on superstructure when elevated. Work dependent upon water surface elevation of the Cedar River at the bridge (no high water).
