Miller-Hull presentation points:

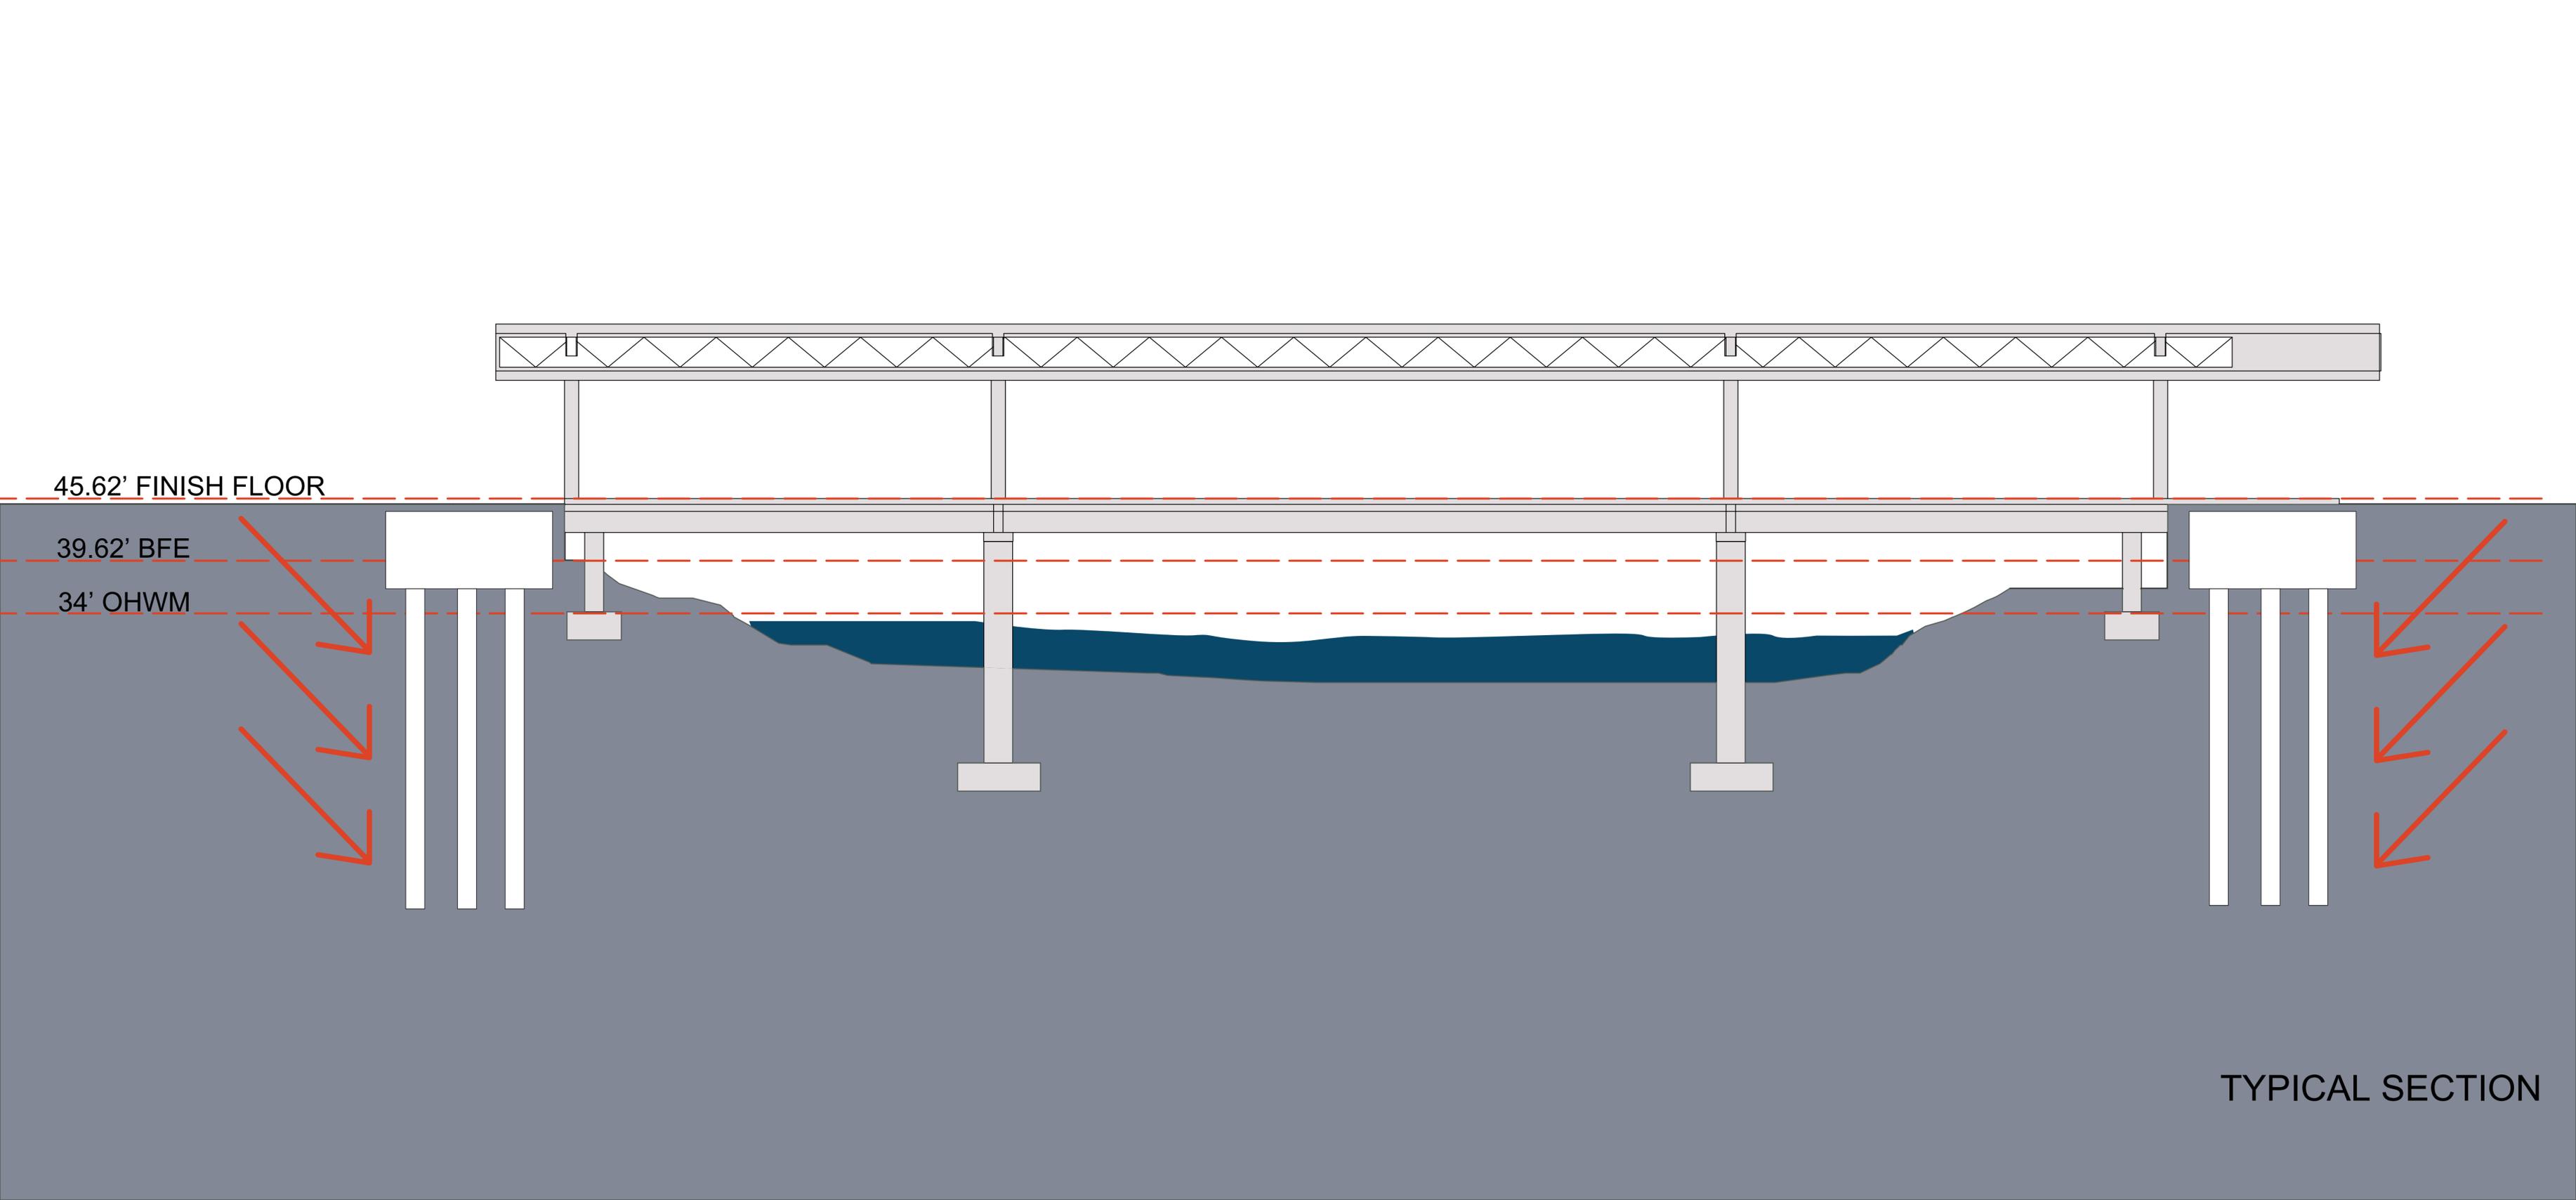
TYPICAL SECTION

45.62' FINISH FLOOR

39.62' BFE

34' OHWM

Meanwhile, structural engineers continued their study of the existing columns, beams, deck and structure. The understructure is clearly understood to be non-compliant with current codes, and in fact, potentially quite unstable in its present condition - in the case of certain seismic events.

The direction of this study was to determine whether the structural and seismic code deficiencies might be addressed by the creation of concrete anchoring “pads”, extending below the surface for roughly the same width as the exterior north and south library walls. The “pads” would be supported by deep piles. This methodology provides two main advantages, potentially; the elimination of the need to work below the Base Flood Elevation and Ordinary High Watermark, which would increase the number of environmental permits required and second, the stabilization of the entire structure in its weakest direction.
